EFFECT OF INSULATOR APPLICATION ON THE LEAKAGE CURRENT PERFORMANCE OF WOODPOLE DISTRIBUTION LINE STRUCTURES

A research report submitted to the Faculty of Engineering and the Built Environment, University of the Witwatersrand, Johannesburg, in partial fulfilment of the requirements for the degree of Master of Science in Engineering.

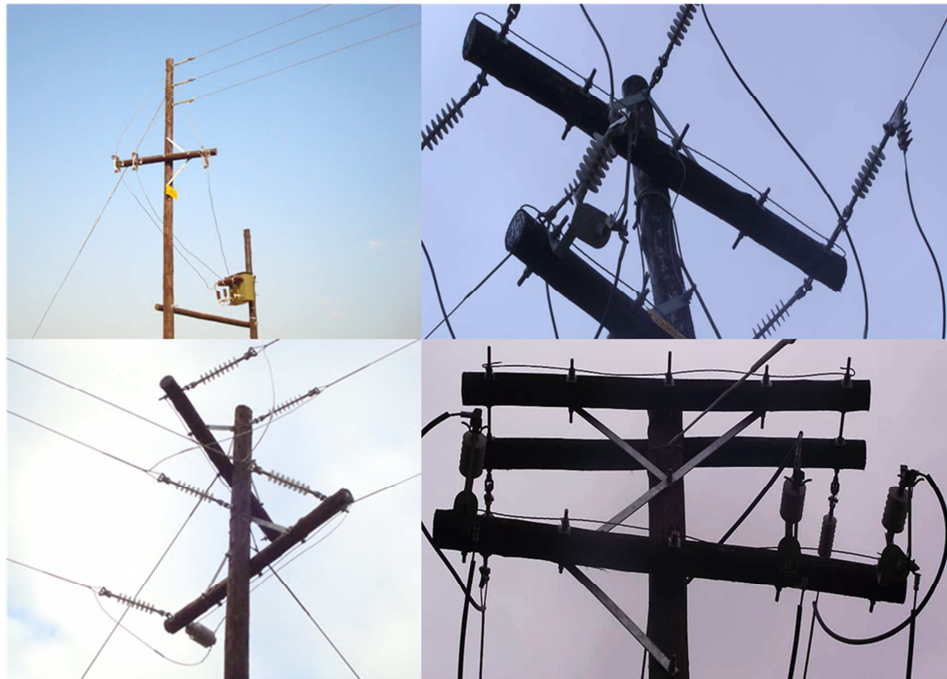
Figure 2.5: Examples of complex woodpole distribution structures

Daveniza's work was published in the 1980's. The book gives details of electrical properties and electrical performance of wood and information pertaining to pole-top fires. Daveniza defined long-term and short-term factors that contribute to the burning of the woodpole structure as: age of the structure, loosened connection at wood and metal interface, pollution on phase insulators, uneven surface wetting, light wetting, circulation of air and other weather conditions. The mechanism described has been confirmed in more recent studies [2-9]. An outcome is that structures with more metal-to-wood interfaces (and by extension more sources of leakage current) are more susceptible to pole-top fires than those with fewer such interfaces. More complex structures also provide more opportunity for poor workmanship than simpler configurations. Figure 2.5 shows examples of complex structures from South Africa.

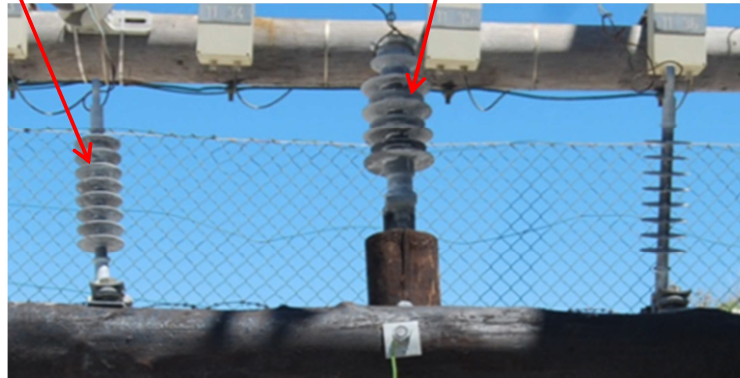
Vertical HTV silicone
rubber long rods insulator
dipped in kaolin

Vertical HTV silicone
rubber post insulator
dipped in kaolin

Figure 3.17: Insulator profile evaluation with HTV silicone rubber post and long rods insulators (same structure setup as Figure 3.16, two insulators changed to HTV silicone rubber long rods)

All the measurements on the structure were conducted at KIPTS for the two cases. Sea water was sprayed to pollute the insulators and the structure for a set of measurements. Thereafter salt solution was sprayed as a pollutant for the concluding measurements.

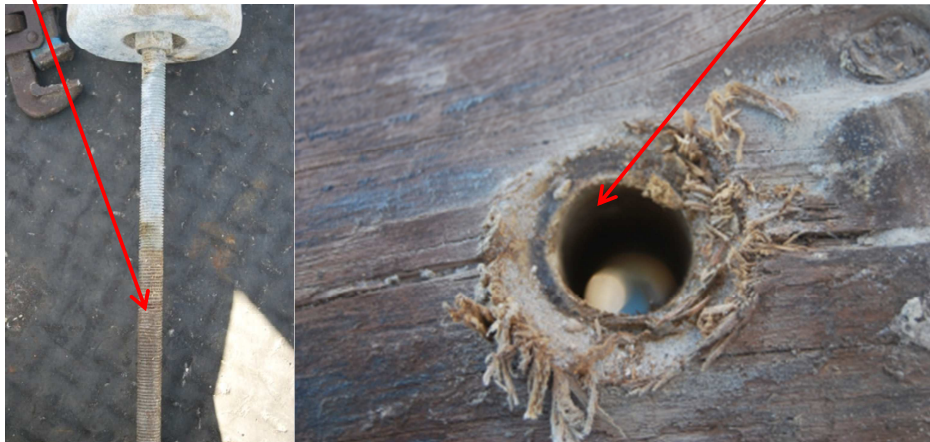
Figure 4.20: Daylight inspection on wood cross-arm

Insulator spindle with
no sign of carbon

No sign of smoldering on wood cross-arm
interface with insulator spindle

Figure 4.20 shows photographs of the wood cross-arm interface with the insulator spindle. No evidence of tracking was observed on the wood cross-arm. None of the inspected structures with wood cross-arms showed signs of charring or had the presence of carbon.

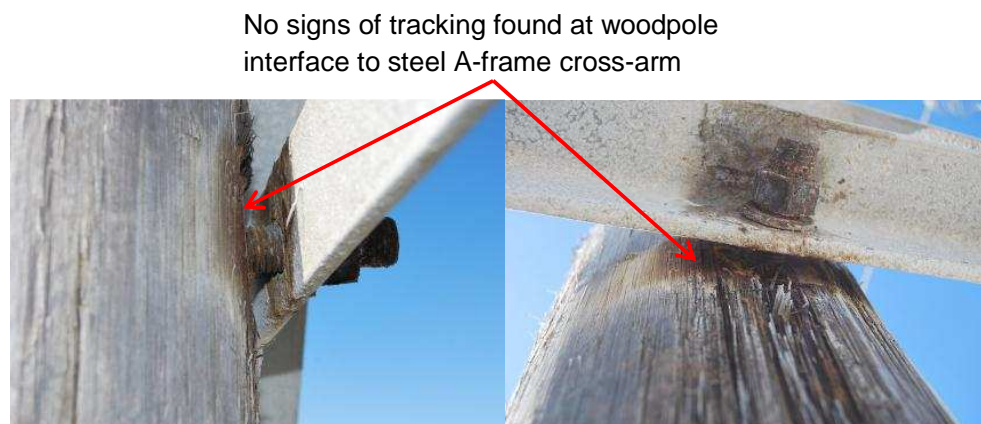
Figure 4.23: Day time inspection on steel A-frame cross-arm interface with vertical woodpole

Photographs of Structure-4 at the interface of the steel A-frame with the vertical woodpole are shown in Figure 4.23. No signs of tracking were observed at the interface.

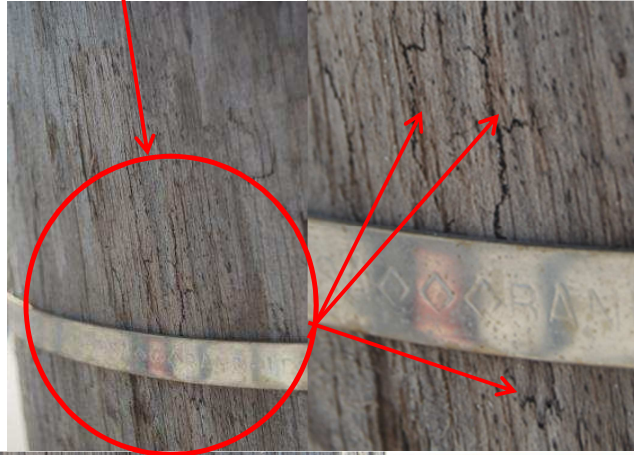
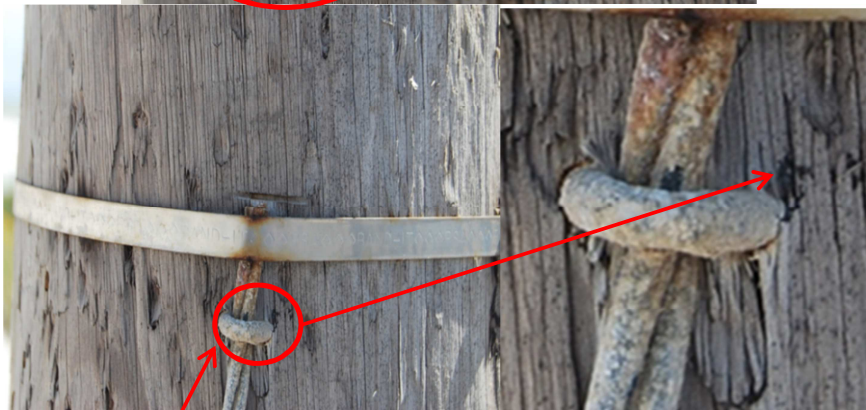
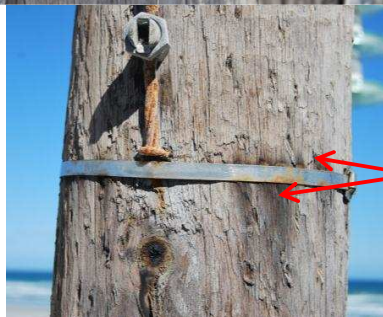
Figure 4.24: Daylight inspection of insulation coordination gap on Structure-2 with woodpole cross-arm and RTV silicone rubber coated insulators

Tracking marks around bottom bandit strap
inside the insulation coordination gap

Tracking marks at the
U-nail securing the
earth downwire at
bottom of insulation
coordination gap

Scorching marks
around the top
bandit strap of the
insulation
coordination gap

Figure 4.24 shows tracking signs and smouldering marks on Structure-2 at the bandit strap inside the insulation coordination gap. There is a risk of pole-top fires for this structure.

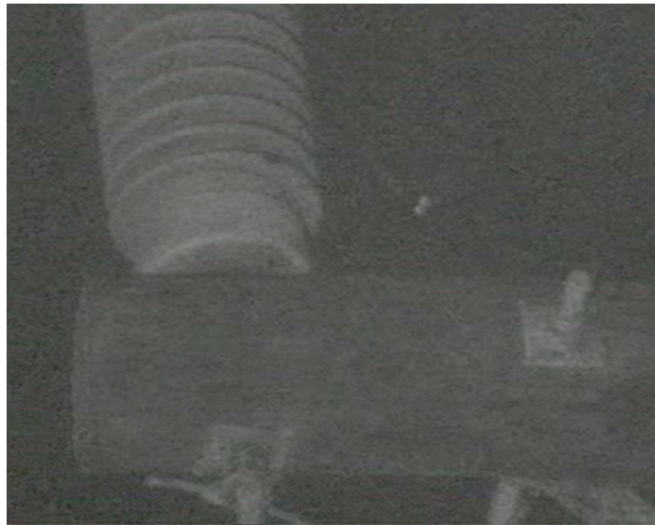
Figure 4.29: Night inspection of cross-arm on Structure-2 with wood cross-arm and RTV silicone rubber coated insulators

No visible activity was observed for the structure with silicone rubber coated insulators as shown in Figure 4.29.

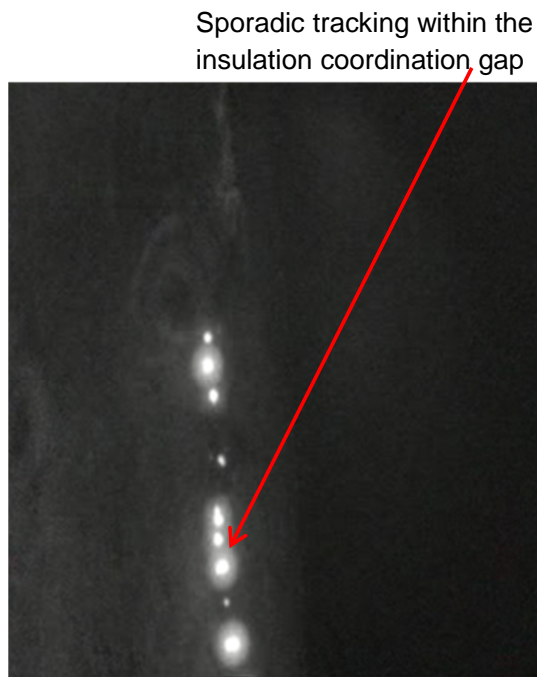
Figure 4.30: Night inspection of insulation coordination gap on Structure-1 with wood cross-arm and all vertical porcelain insulators

Figure 4.30 shows tracking within the insulation coordination gap of Structure-1. The tracking was observed to be sporadic and at times constant. This finding concurs with daylight inspections where burning marks were observed on the structure. No tracking was captured for other structures with insulation coordination gaps during the time of night inspection.
